Due to different installation styles and materials it looked to me like the job had been performed by different crews, or companies. It also appeared that there was not a complete understanding of JH installation techniques.

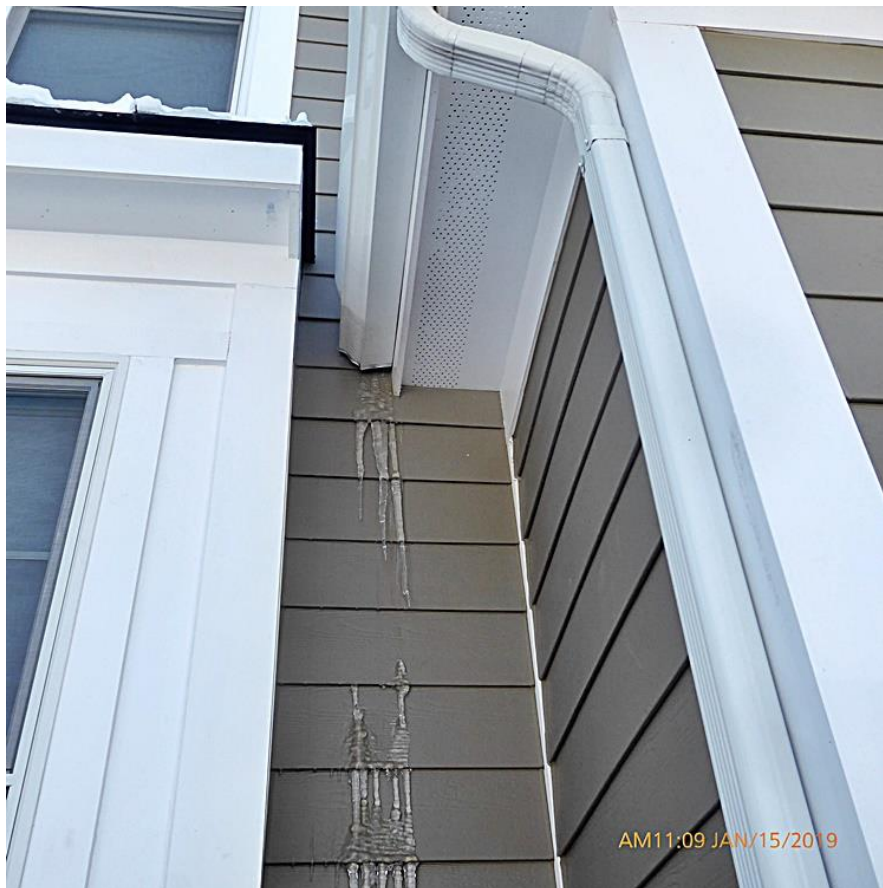
Water has been dripping where the garage wall abuts the main house. Ice has formed obviously. A length of sheet metal has been installed to deflect water from hitting the box window trim, but there was deep snow and it could not be determined if kick-out flashing is present against the house. The gutter is close to the siding, but it was not measured, but JH recommends an inch from the siding.

Kick-out flashing can be seen in diagram 5 of the first link above, page 93, and the gutter distance from the siding in figure 9.

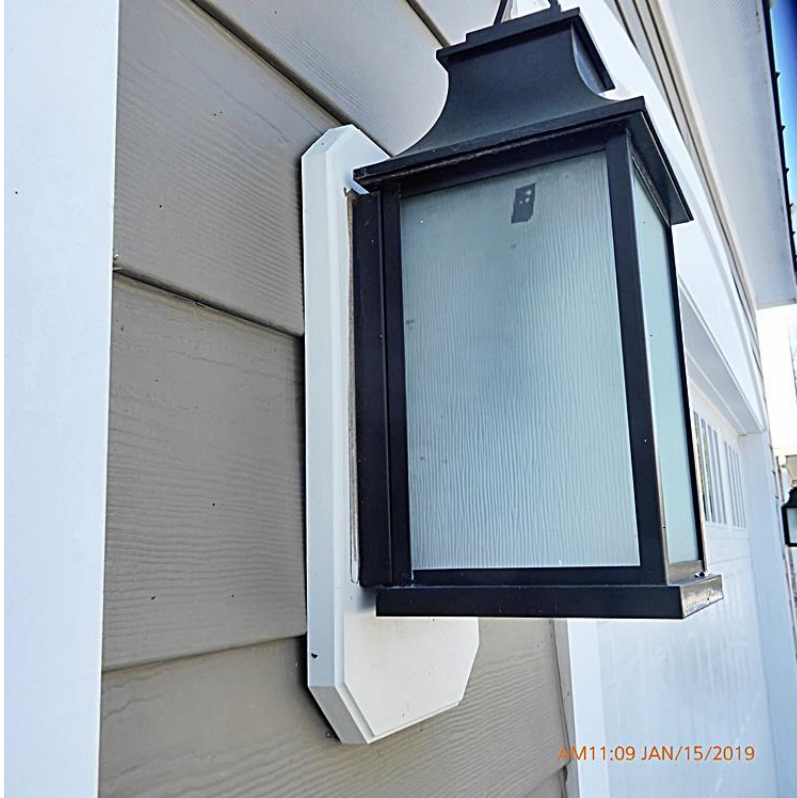
Two different lights on different bases.

Neither base subscribes to the installation instructions on the JH website.

Given the two different bases it is suspected that two different companies installed them?

Fixtures and penetrations should be installed on what JH calls blocks, or Sturdi Mount bases, with flashing over the top similar to windows and doors.

An example of a block can be seen in figure 13 of the first link above, page 93.

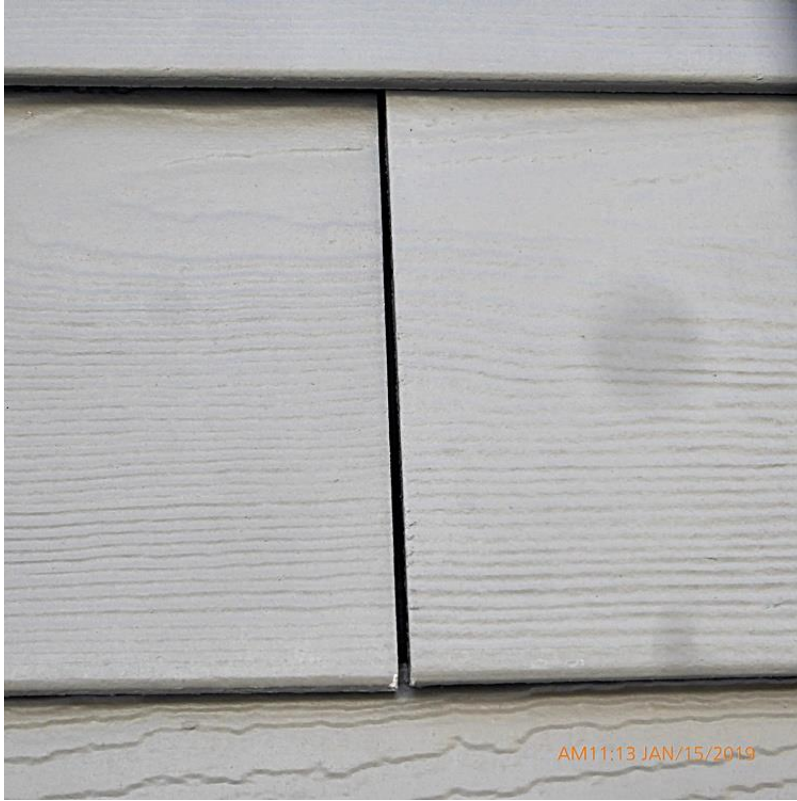
These two photos are examples of the many locations where the butt ends are too far apart.

In the upper photo the separation is about $3/16^{\text{th}}$ " and the lower about $1/4$ ".

JH says that butt joints should have "moderate edge contact." See page 89 of the first link above.

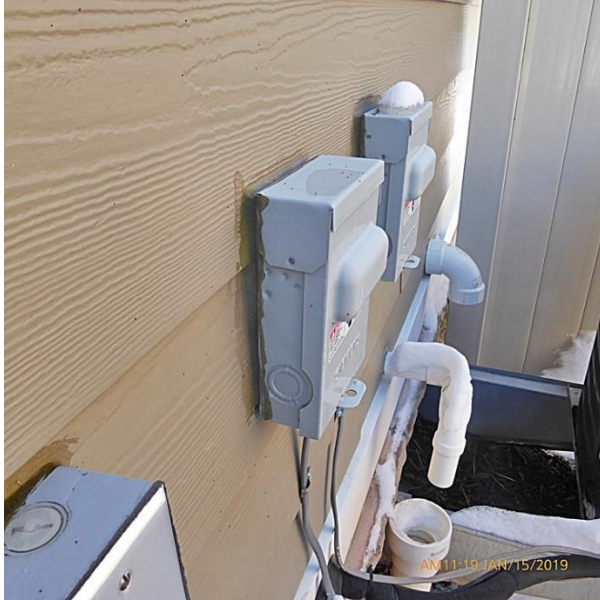
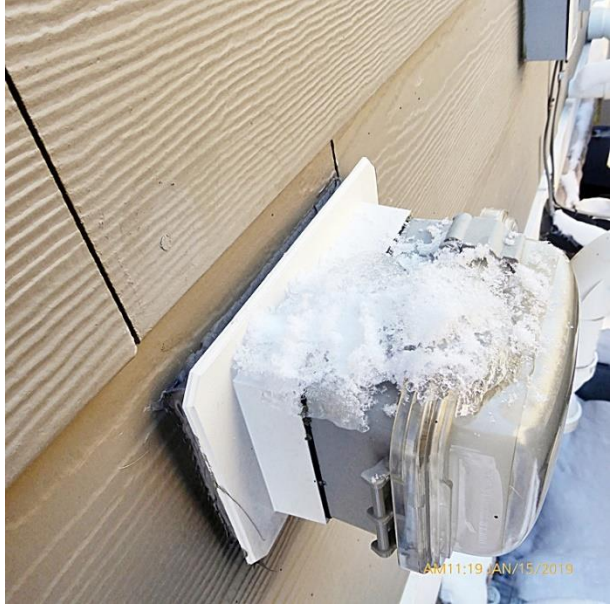
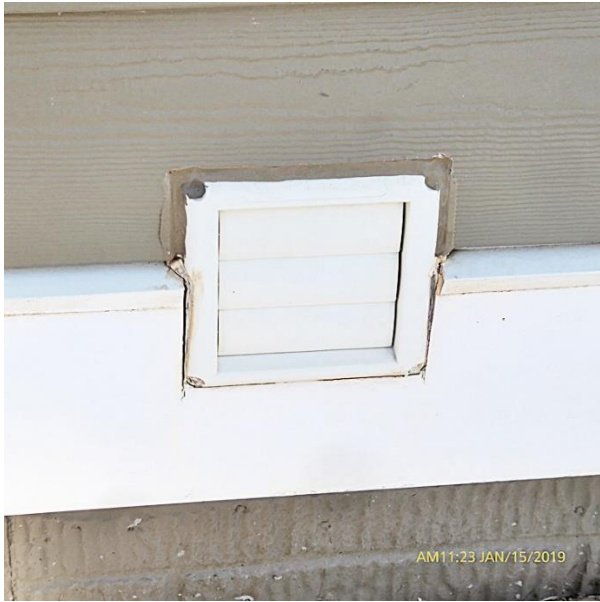
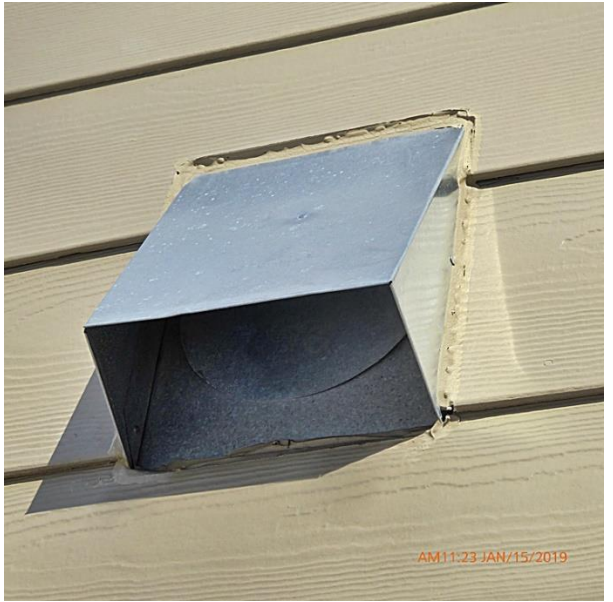
These are other examples of various penetrations not placed on a proper mount, or installed directly into the siding.

Caulking is not a finished edge.

There is no flashing over any of these penetrations.

The installer seems to be guessing about how to install things. And the caulking is not the least bit professional or attractive.

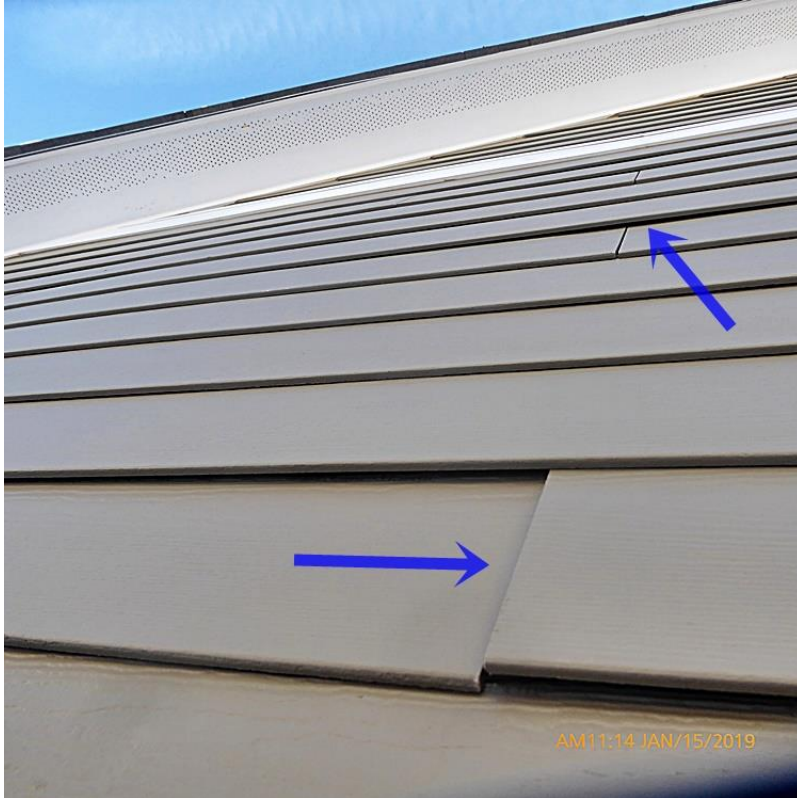
Both photos are representative of the many butt edges that are not in plane.

Notice the face nailing, too far from the joint. See figure 15 on page 94 of the first link above.

Being so far apart neither nail can be into a stud, which is the only way the plank could stay firmly attached to the wall.

The upper arrow in the top photo shows a loose plank.

Such looseness is all over the house.

Loose planks can happen for many reasons, but mostly because of improper nailing.

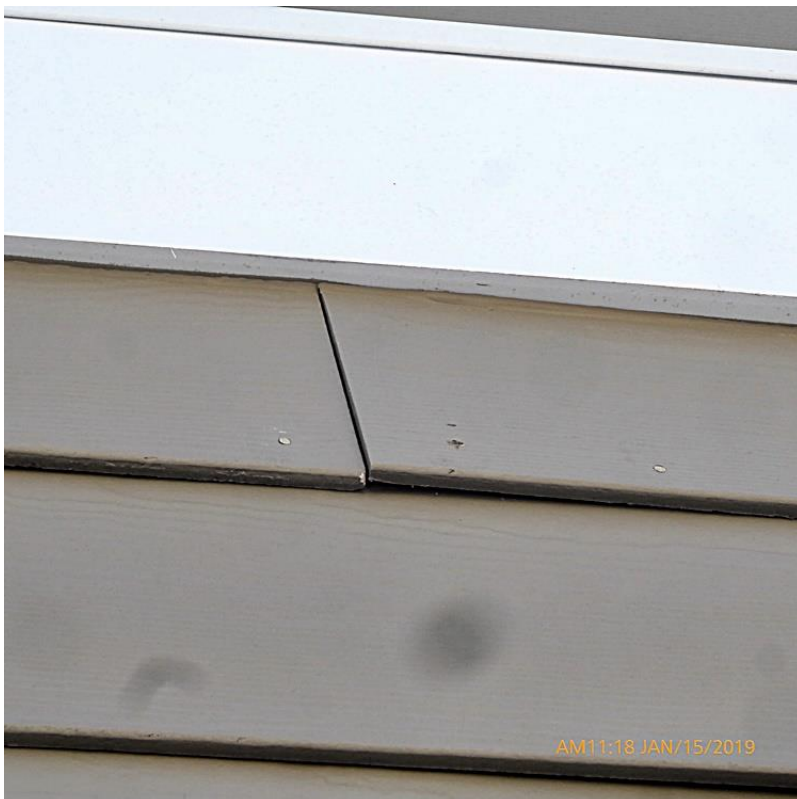
On the topic of nailing, I could not feel that there was a starter strip on the lowest plank anywhere on the house. A starter strip is explained on page 86 of the first link, one of many such explanations.

Nails on topside of each plank should be placed between $\frac{3}{4}$ " and 1" from the top edge.

And there should be a minimum overlap of $1\frac{1}{4}$ " of one plank over another.

See figure 2 on page 92 of the first link above, and figures 14 and 15 of page 94.

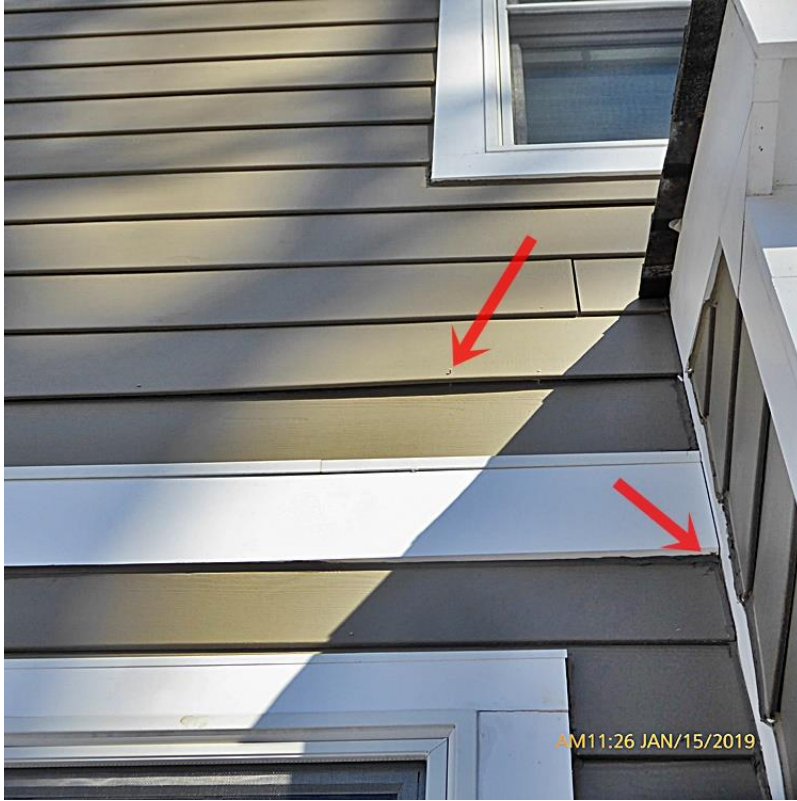
More examples of poorly installed siding and trim.

Looseness abounds.

Again, these photos are merely representational areas all over the house.

The upper red arrow in the photo to the left points to a loose nail, albeit barely visible.

The nail could not be into a stud and it is too short (more on such short nails later).

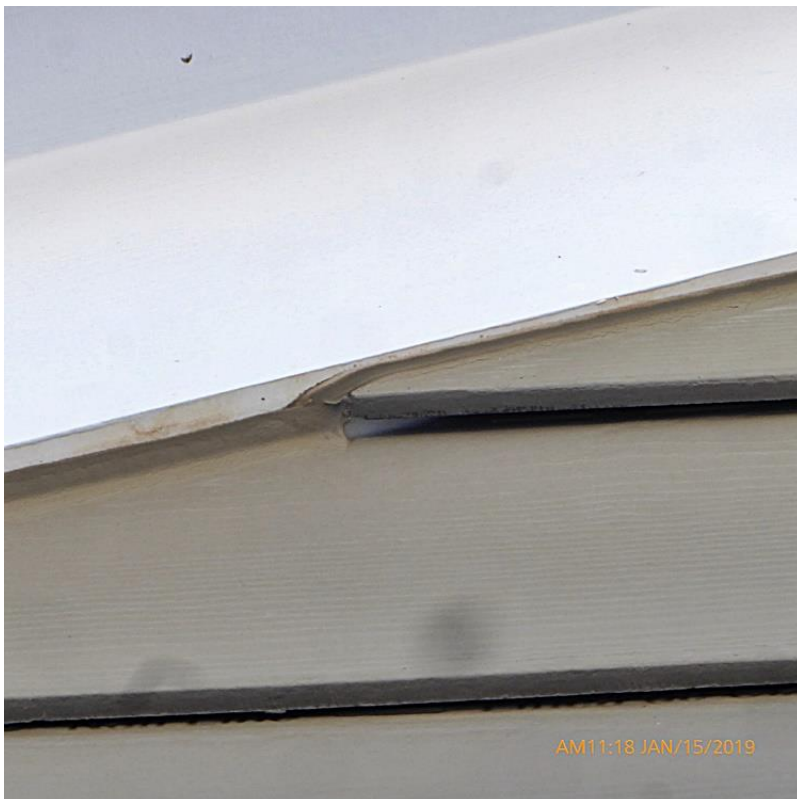
This lower photo is an example of the loose edge of the tops of many planks along the roof fascia.

This edge is held in place with caulking, and not very well.

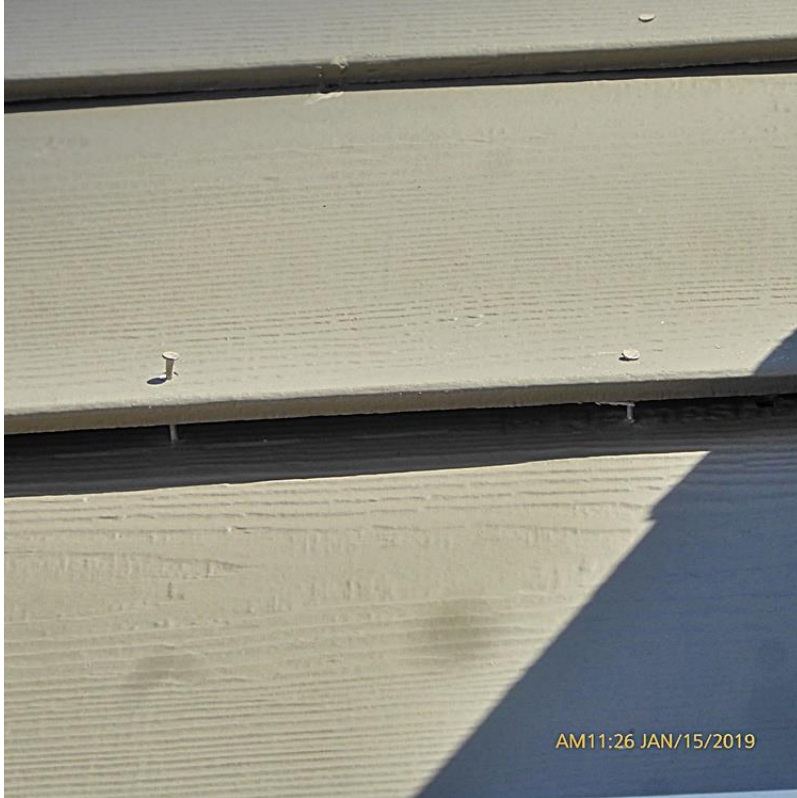
More loose face nails, very small and very short.

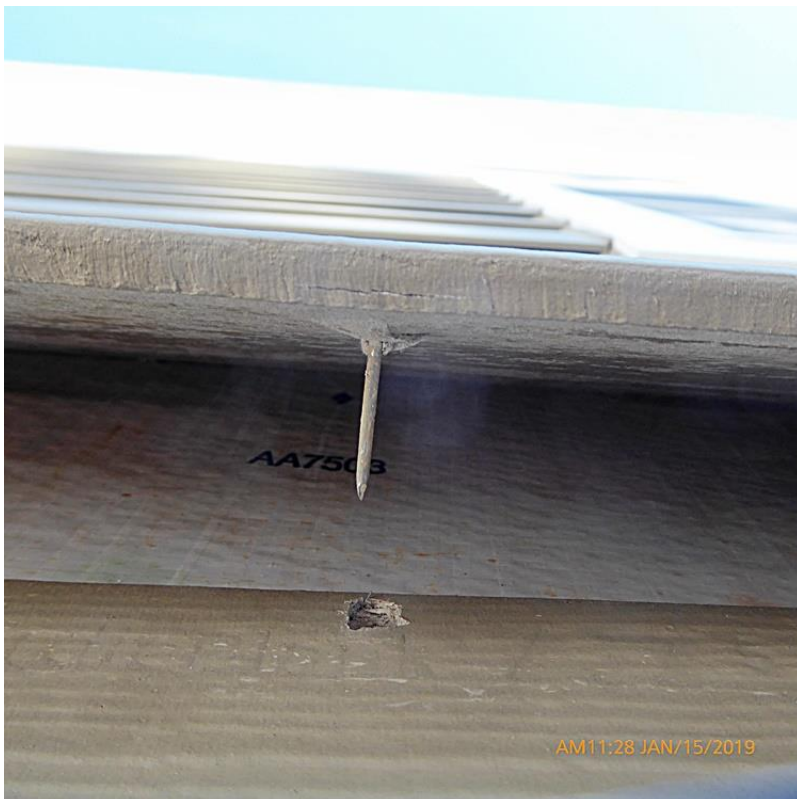
This looseness is likely caused by driving a nail (too small and too short) in too hard.

It grabbed nothing inside the wall, and gouged a large hole into the top of the plank it overlaps.

Face nails, and all such blind nails, should be driven between $\frac{3}{4}$ " and 1" from the top of the plank. See page 88 and figure 10.5 on the first link.

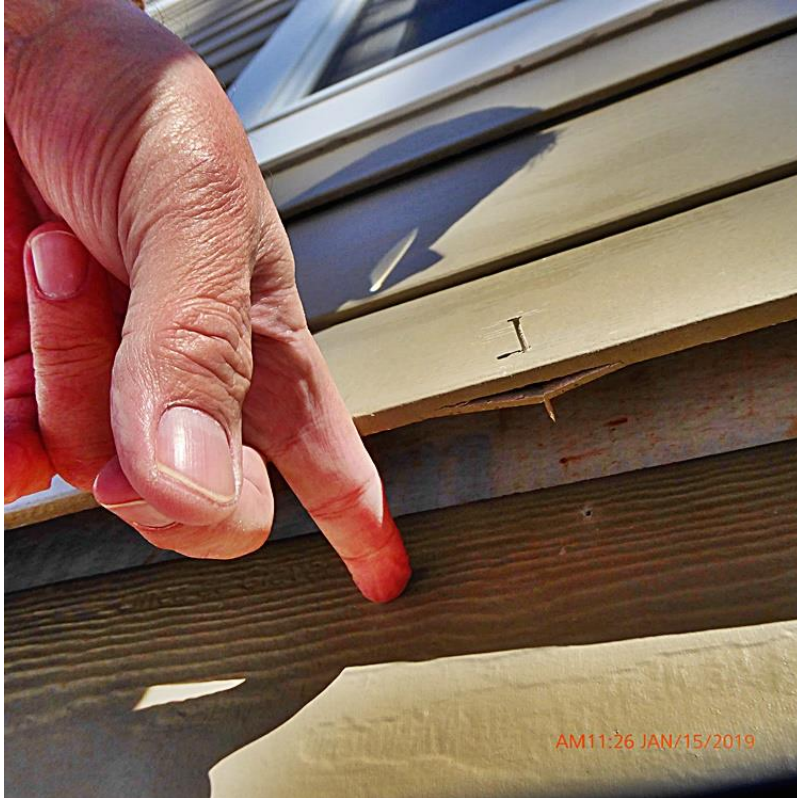
This plank was so loose it could come out to the second joint on my finger.

The nails was driven so hard it split or delaminated the plank.

It also was too short and could not have been driven into a stud as it is loosely attached all around.

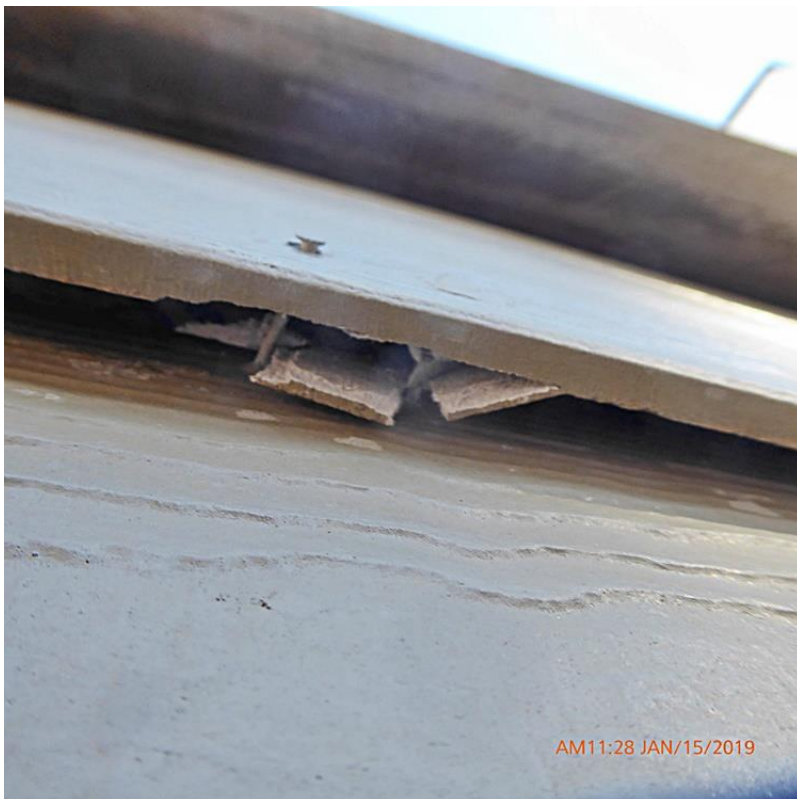
This is an example of two face nails placed too closely together. Why is that necessary?

Again, they are not and cannot be secured into a stud.

Beyond that, both were driven so hard they also split the plank.

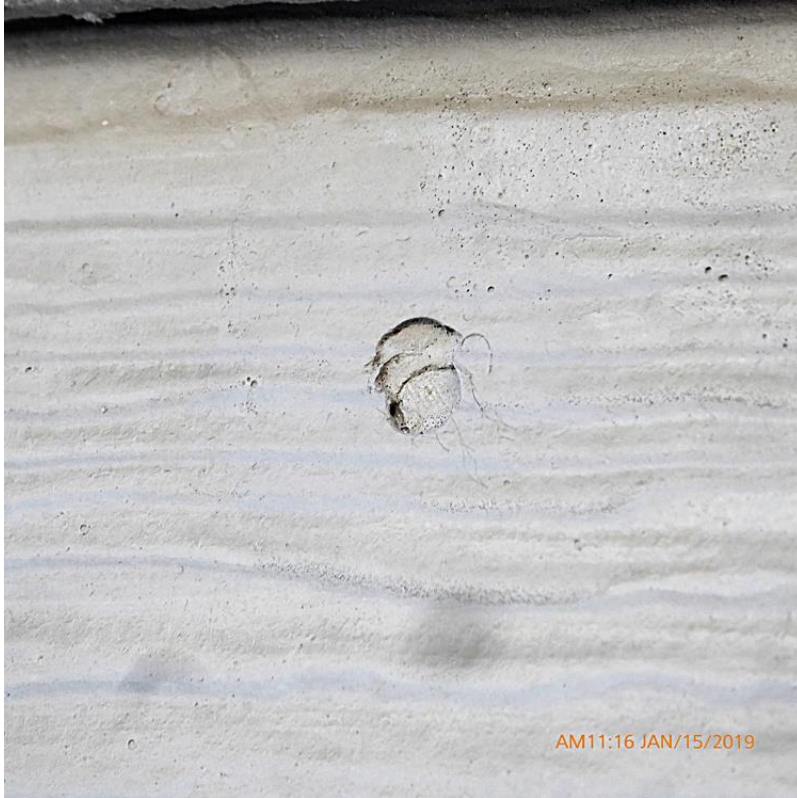
This nail, and maybe two nails, broke the skin of the plank.

This is another example of improper face nailing.

And this is only one example of many such a buried nail heads.

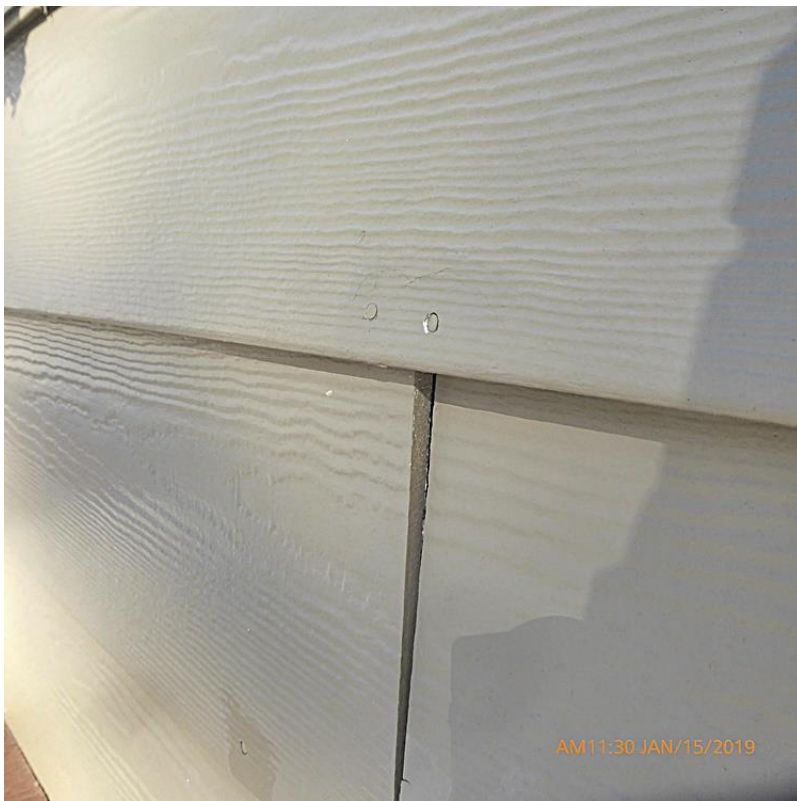
Again, we have butt ends not in plane.

And these are under a plank on top which also got two nails apparently to try to secure or push the planks below into alignment.

The nail on the right is driven too deep and has punctured the skin.

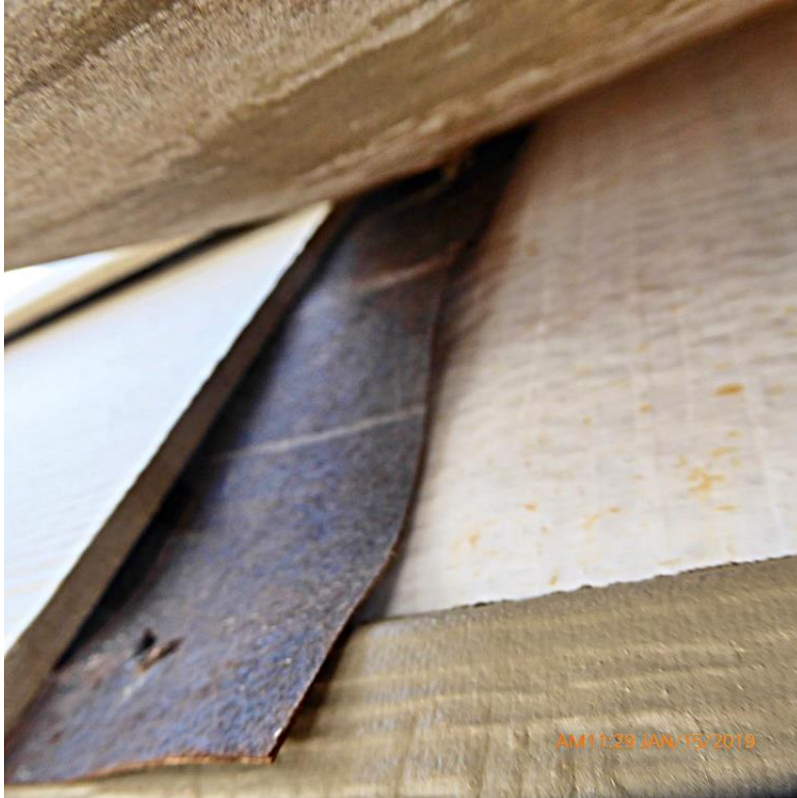
This is the material used as joint flashing.

It looks to be roof felt.

While JH would prefer a hard joint flashing, but anything that is waterproof and not aluminum is acceptable.

The problem with such felt is that it is very weak and susceptible to tearing.

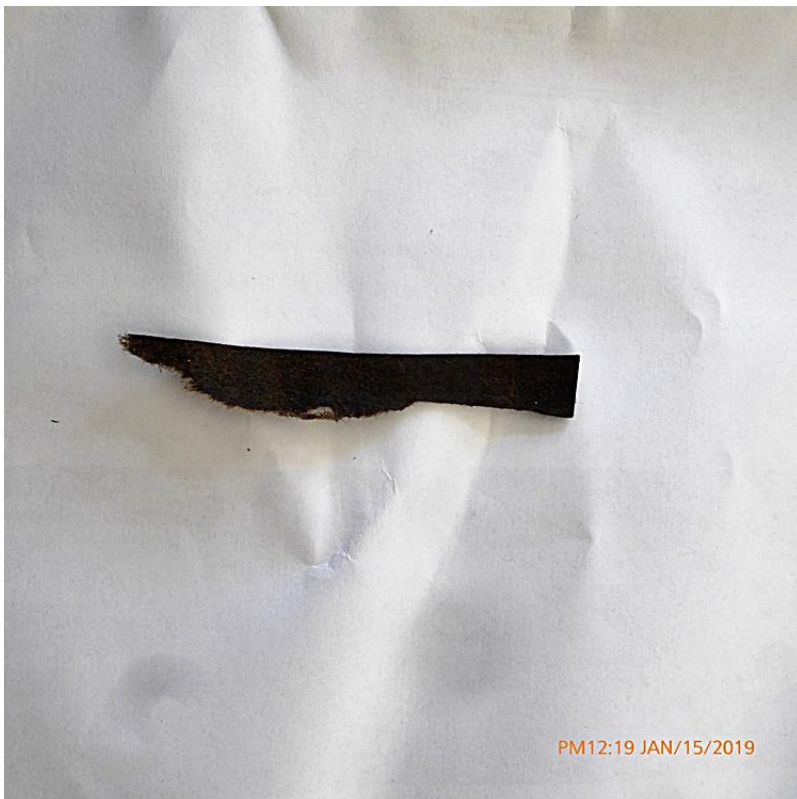
This piece of joint flashing felt was found hanging behind a loose plank.

What held it in place was the plank above.

It would have eventually fallen sometime in the future as wind would lift and lower the loose plank.

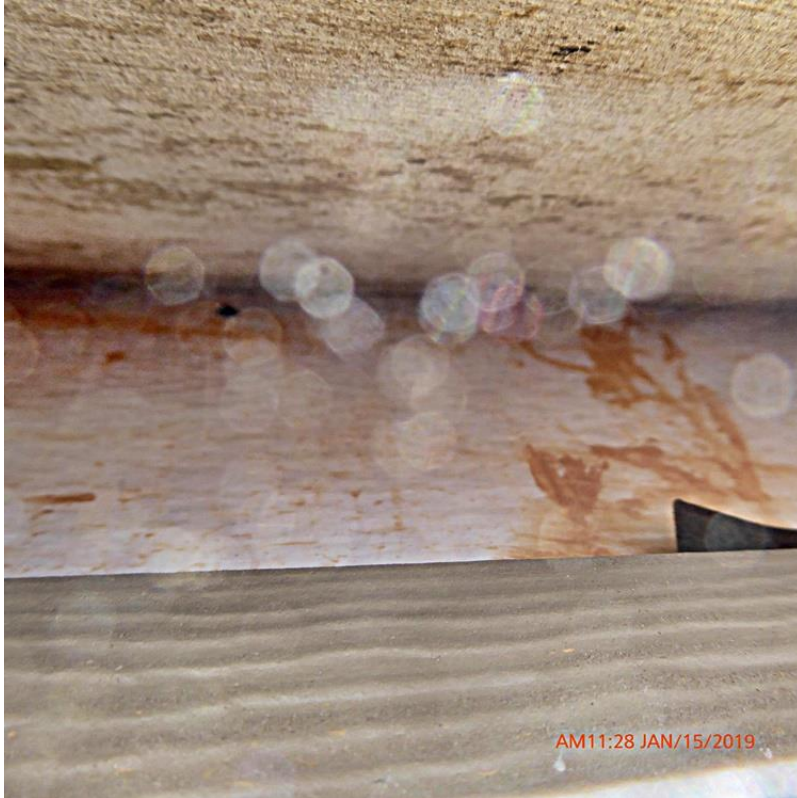
When this very loose plank was lifted water marks could be seen.

In fact water marks could be seen in many areas when loose siding was lifted.

It is feared that water is getting behind the siding.

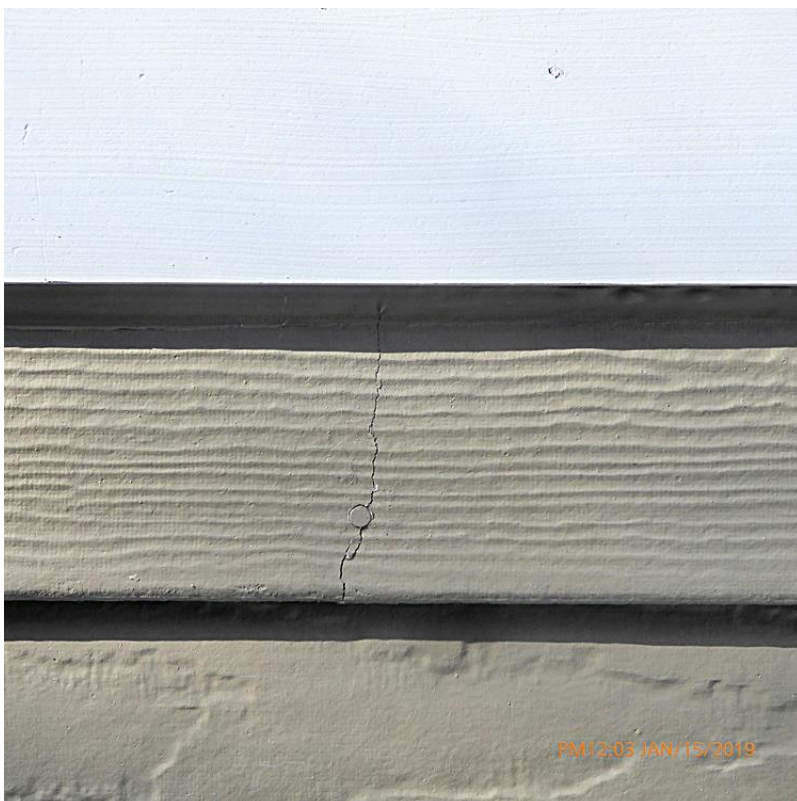
The nail here was driven so hard it cracked the siding under this window trim.

On this side of the house two cracked siding planks could be seen.

It is suspected that there are many more not seen, and perhaps hidden by paint.

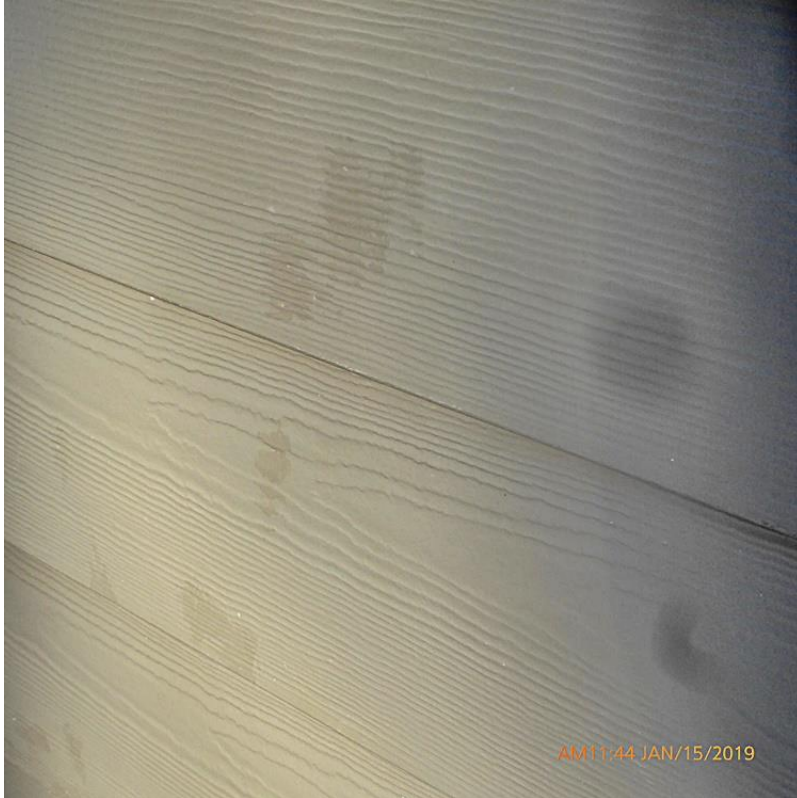
This photo is an attempt to capture examples of the erratic paint.

The two spots on the right are light playing with the camera lens.

Such erratic paint was evident all over the house.

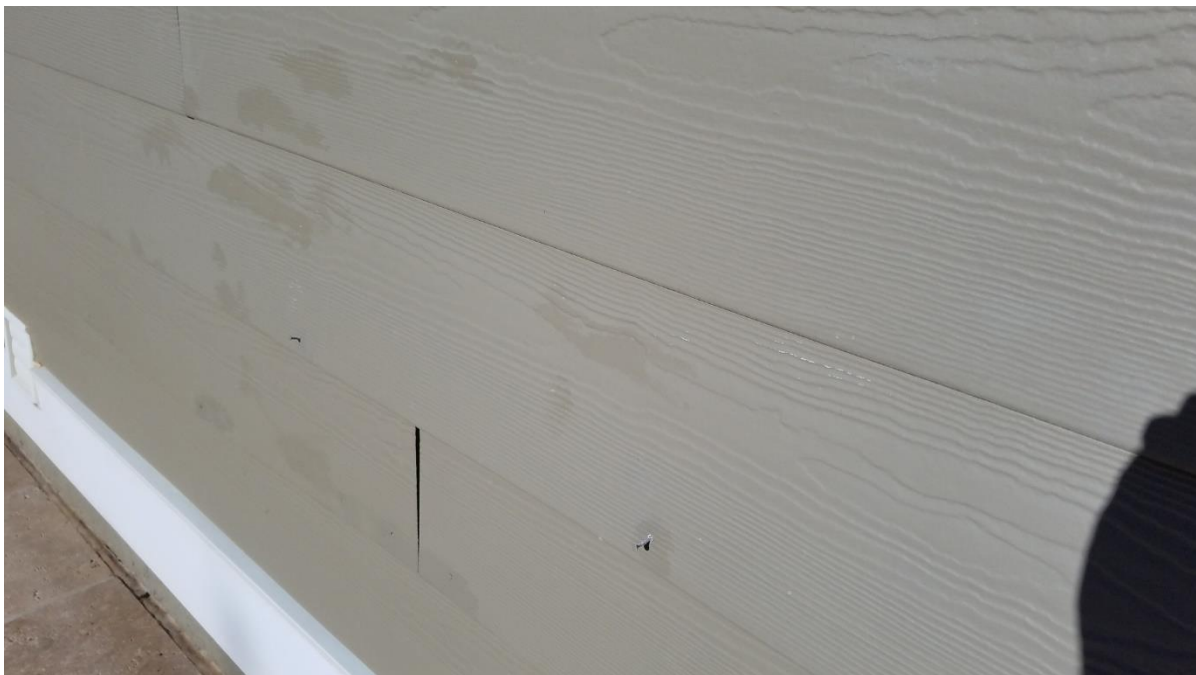
This lower photo is a cropped example of another location with similar paint.

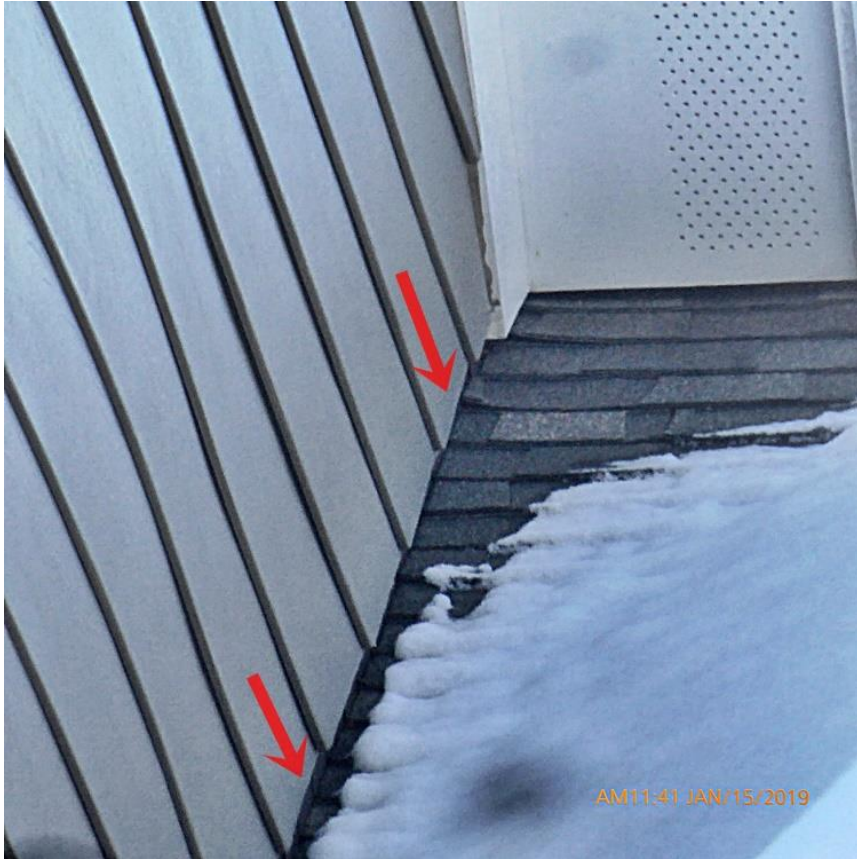
Looking from the street at the wall above the garage roof, the lower arrow points to what appears to be siding the recommended 2" from the shingles.

It could not be measured.

But again, looking from the street, the higher shingles, as indicated by the upper arrow, looked to be very close to the shingles.

See figure 3 on page 93 of the first link above for the 2" distance between siding and shingles.

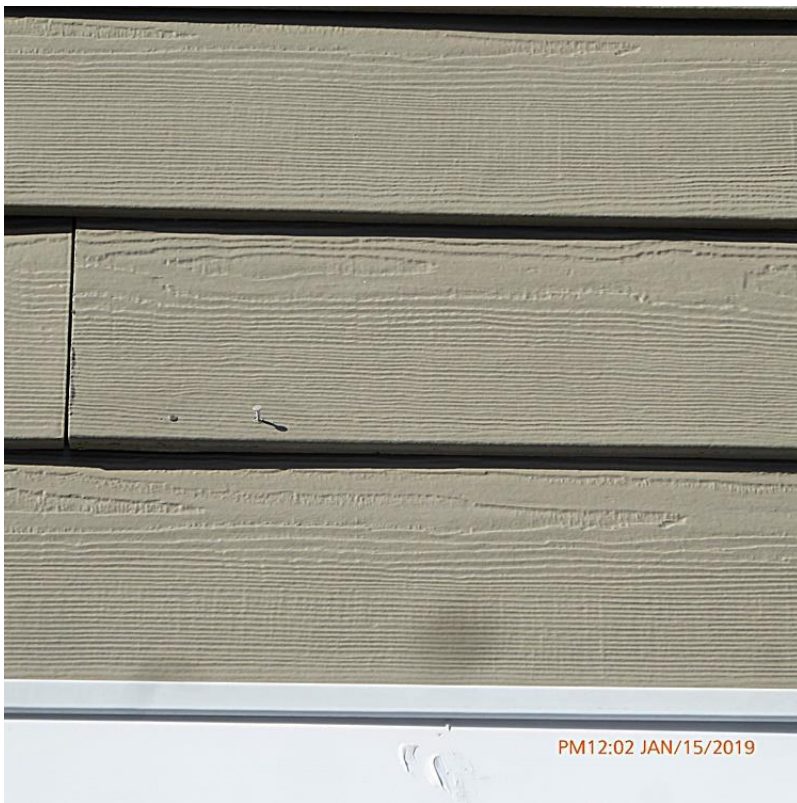
One more example of improper face nailing, with small nails which have come loose.

And again, this is only one of many such examples around the house.

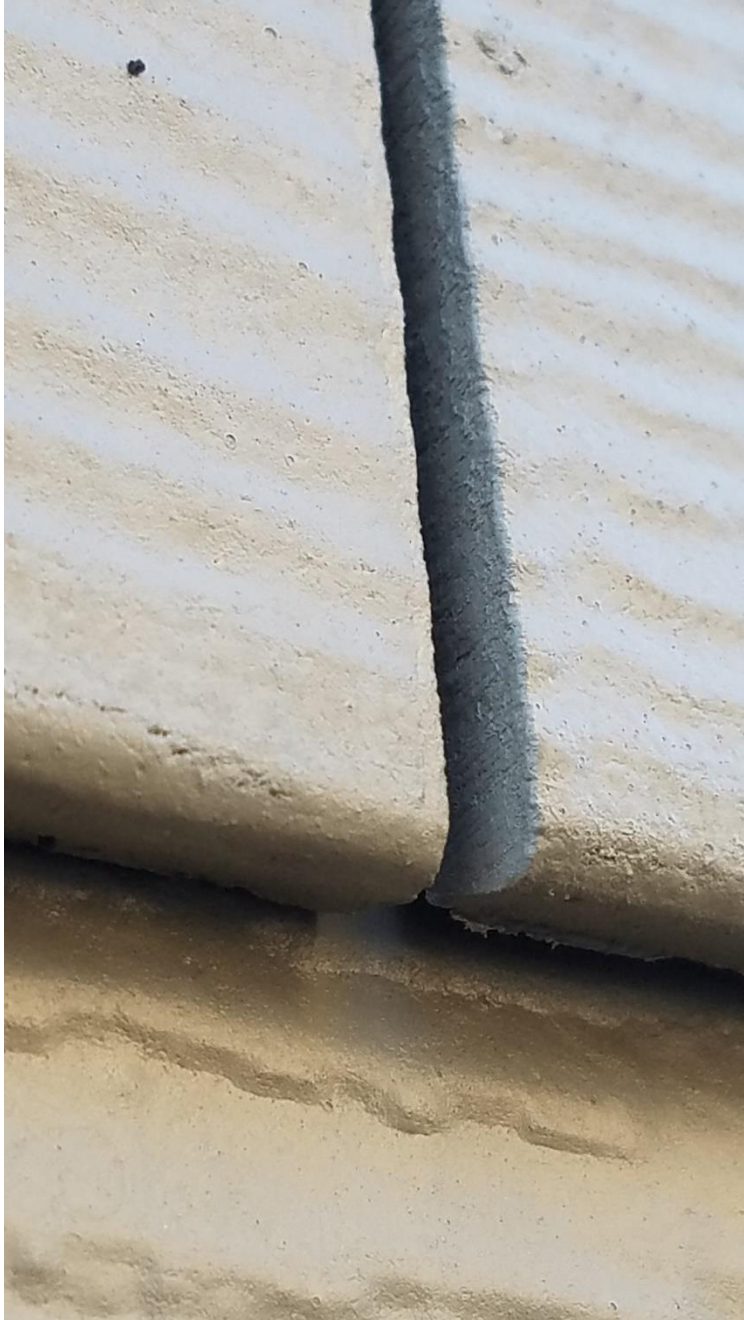
Since the edges contain so much cellulose, and it is said as much as 50%, the edge will be susceptible to moisture intrusion and damage.

The edge will discolor and swell and deteriorate if not treated.

Similar to such locations as the photo to the left, the cut edges of the siding along the roof in the photo on the previous page would also ALL need to be so treated.

The sealing of the undersides of these cut siding members would have to be verified by climbing on the roof to see.

All cut edges should be painted or treated with a JH sealant.

See page 28 of the second link above.

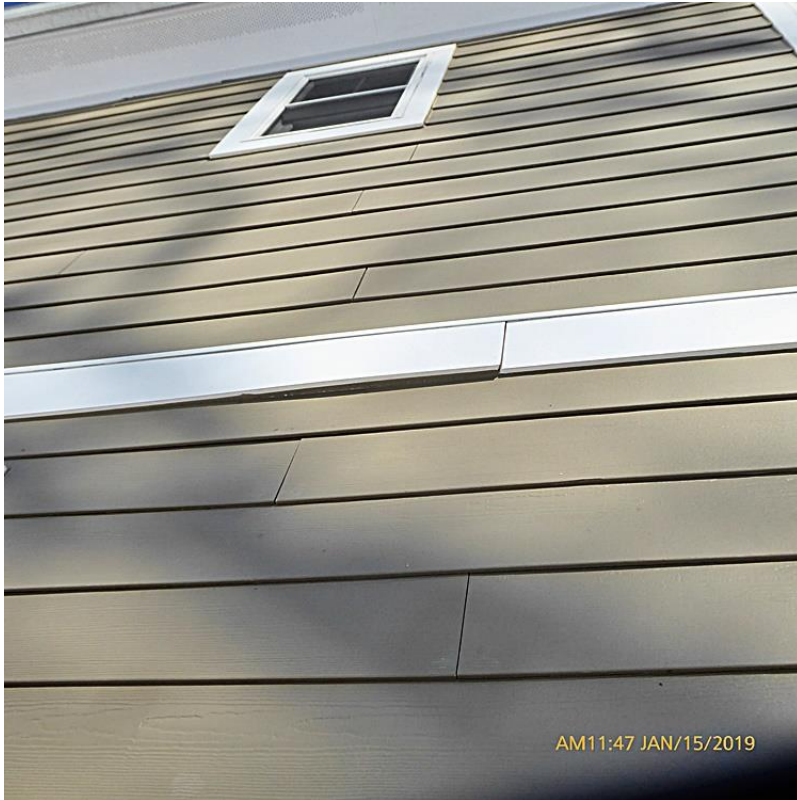
More loose trim, and general waviness of the siding.

Again, this is due to improper nailing.

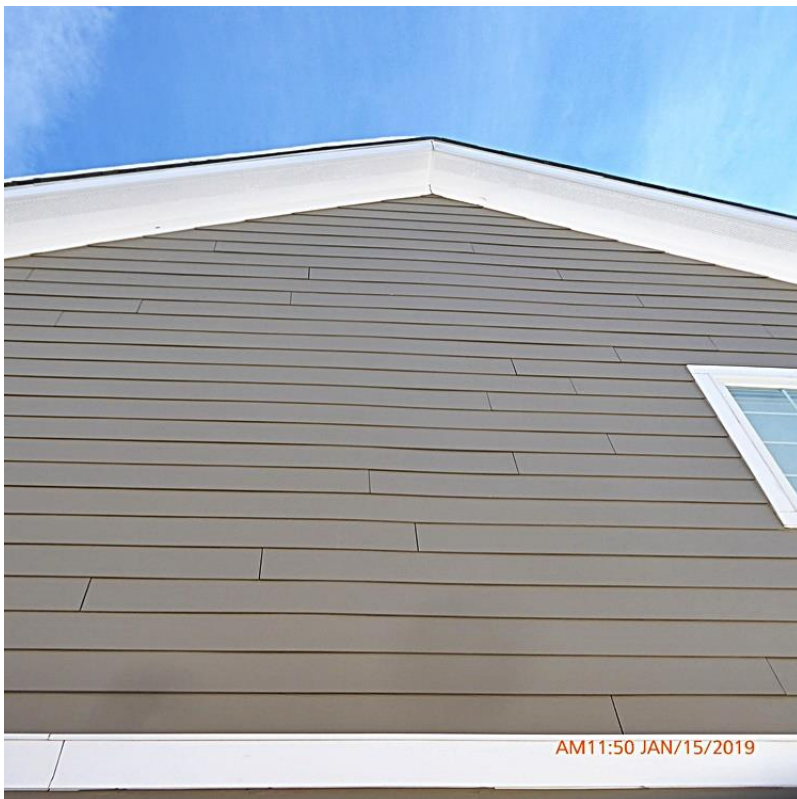
Perhaps hard to see in this photograph, but there is great waviness and looseness in the entire face of this wall.

Improper nailing and siding installation is the reason.

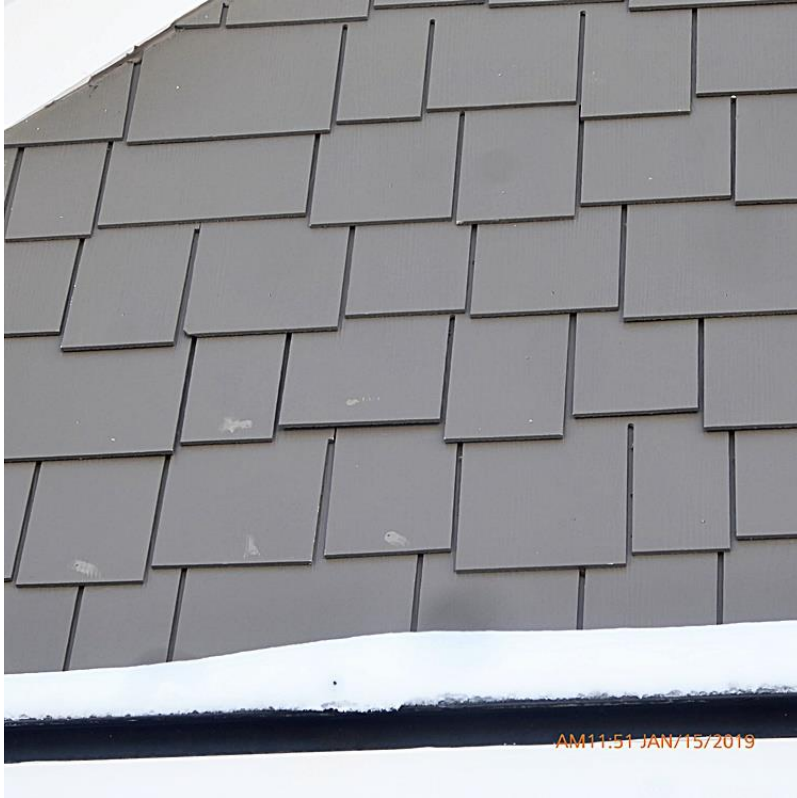
The shingles on the front of the house, over the garage door, were all wavy, erratically placed where edges did not make sense, and had touch-up paint over face nails that did not match.

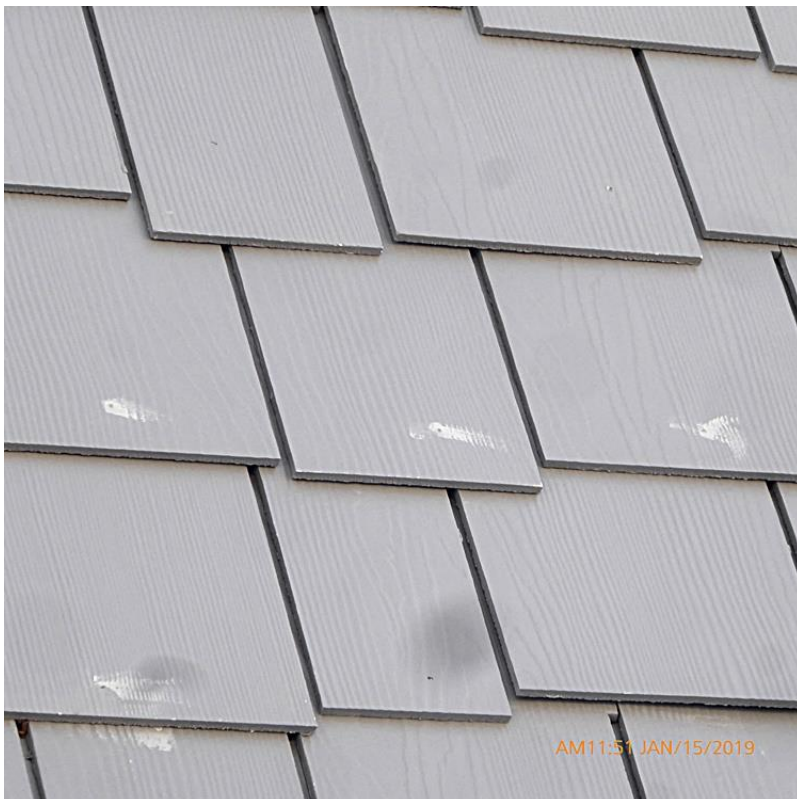
This is another example of the same area, with touch-up paint that does not even look to be close to the same color.

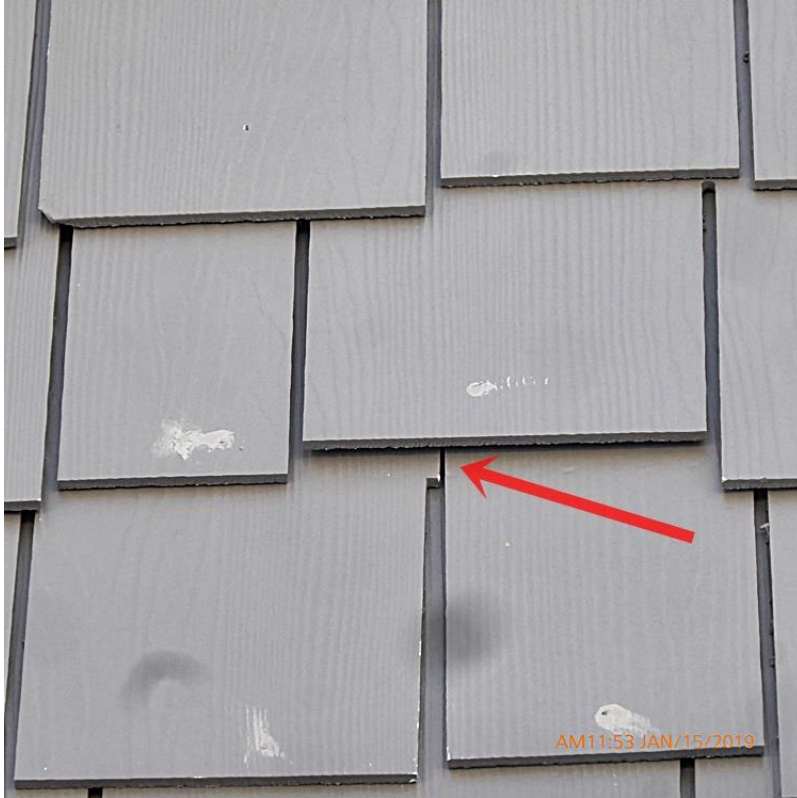
And here is a final example of the same area.

This also shows looseness of the shingles, and the red arrow points to a spot on the shingle that should have been buried beneath the shingle on top.

This is an example of an edge that does not make sense.

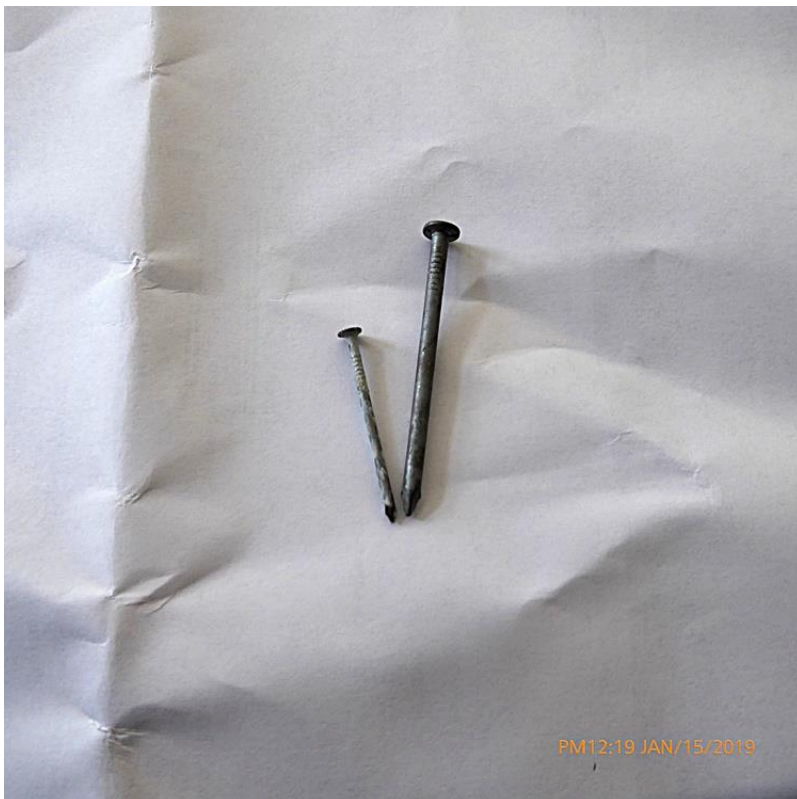
This photo is instructive.

The nail on the left was removed from the siding. It was hanging very loose, so it was removed.

The nail on the right is an example of the kind of nail recommended as a fastener on page 91 of the first link above.

The nail on the left appears to be aluminum, forbidden by JH as it will interact badly with the cement.

The nail on the right is galvanized, properly sized, and appropriate.

If the nails we can see are aluminum, what of the nails we cannot? Are they also aluminum? Were aluminum nails used all over the house? If so this would cause severe problems with the siding all over the house!
