Due to different installation styles and materials it looked to me like the job had been performed by different crews, or companies. It also appeared that there was not a complete understanding of JH installation techniques.

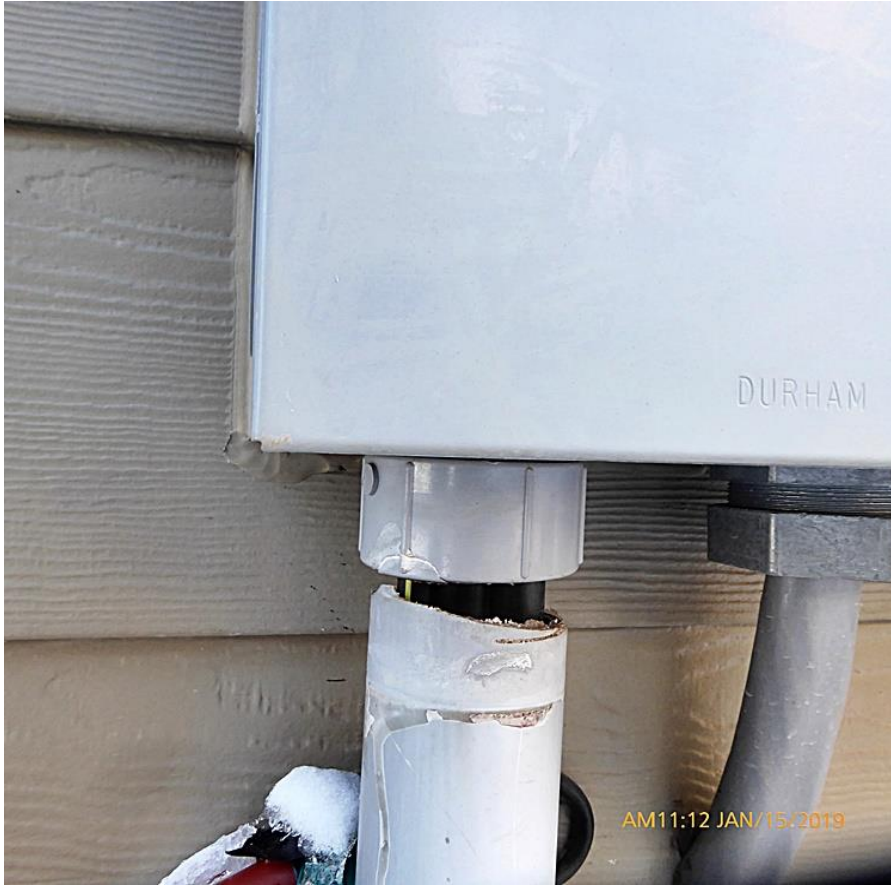
The photo to the left is another issue.

The conduit servicing the electric meter was not given a slip joint.

As such, as the soil settled over time, the conduit pulled away also, approximately 2", exposing the service

conductors inside. This is something that needs to be remedied sooner rather than later.

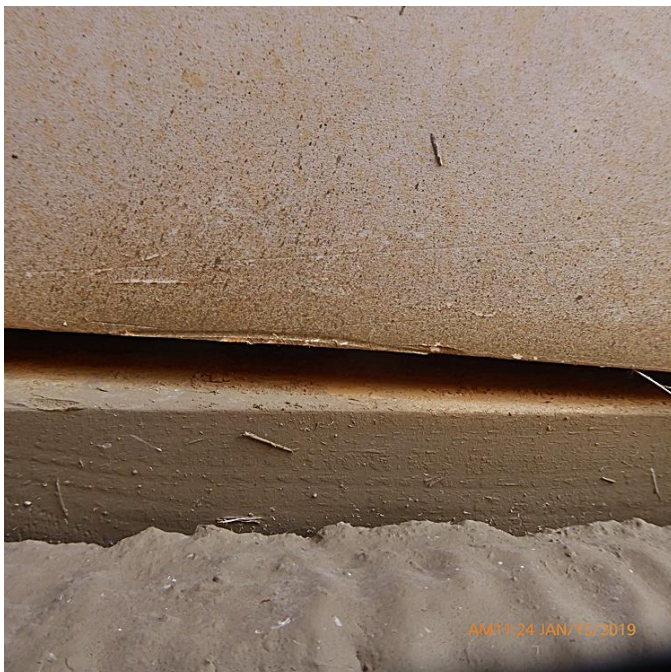
Looking under the box penetration housing the fireplace it could be seen that the gap between the soffit cover and the sides and where it abuts the house was never caulked.

It appears to have never been primed or painted.

The covering was also bowing downward.

This likely means the insulation has pulled away from the sub floor, which creates a cold floor and cold air coming in through the fireplace.

Cold air could in fact be felt in front of the fireplace.

The cover needs to be removed on the underside of the wall penetration outdoors, the insulation needs proper placement, and the cover needs to be installed properly, being primed and painted, and sealed against air intrusion with caulking.

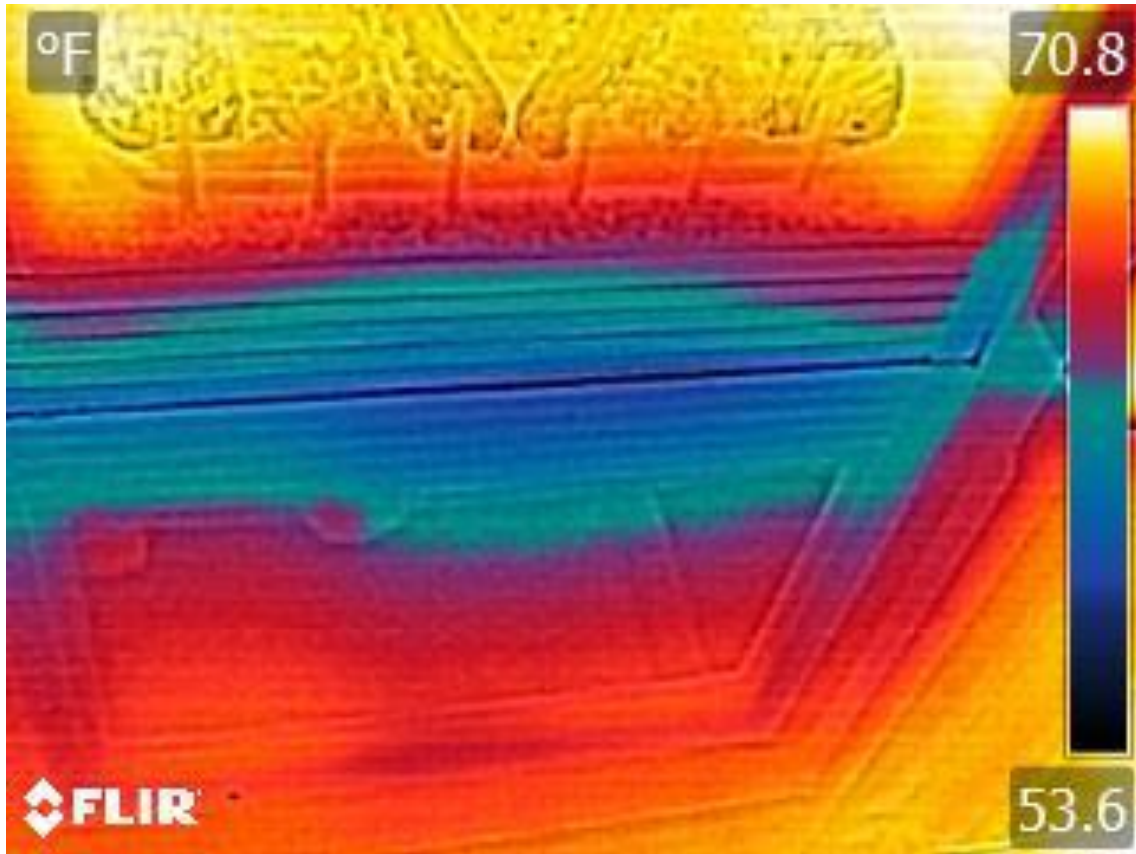
This is a thermal image of part of the area in front of the fireplace. It is very cold, almost 54F, which can be felt standing in front of the fireplace in stocking feet.

And when looking at the cooler areas, indicated by blue, the image indicates that the cold is progressing onto the hearth.

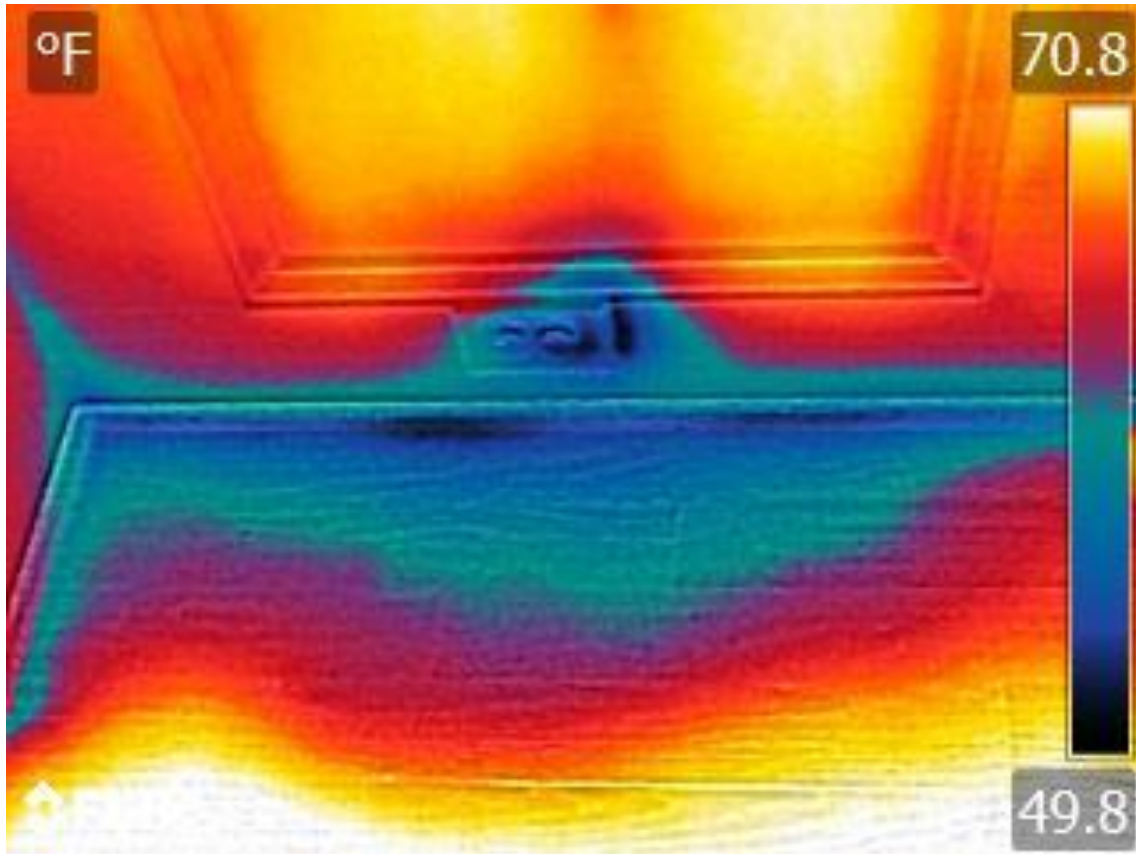
Due to ice and snow the underside of the penetration in the front bump out (dining room), to the right of the front porch, could not be seen.

However, it is similarly cold, which might mean a similar condition exists with the insulation, soffit cover and air intrusion.

Also, it is evident that the receptacle box was never sealed against air intrusion, typically done with foam.

The temperatures here are very cold, as low as 49.8F.
