Due to different installation styles and materials it looked to me like the job had been performed by different crews, or companies. It also appeared that there was not a complete understanding of JH installation techniques.

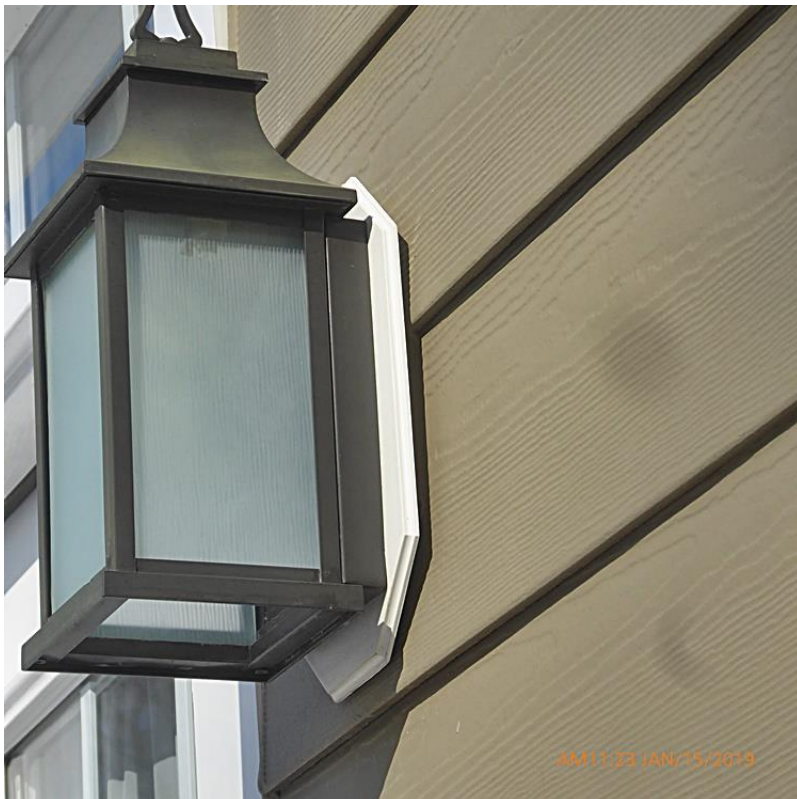
Two different lights on different bases.

Neither base subscribes to the installation instructions on the JH website.

Given the two different bases it is suspected that two different companies installed them?

Fixtures and penetrations should be installed on what JH calls blocks, or Sturdi Mount bases, with flashing over the top similar to windows and doors.

An example of a block can be seen in figure 13 of the first link above, page 93.

Page 19, 20 and 21 of the second link above has an additional explanation of the various desired bases.

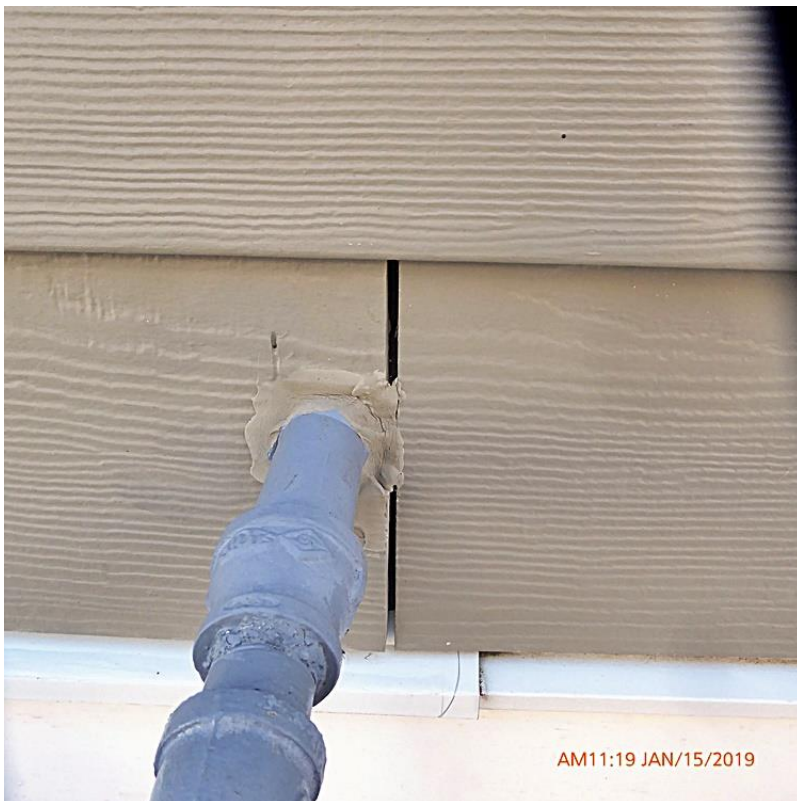
These two photos are examples of the many locations where the butt ends are too far apart.

In the upper photo the separation is about $3/16^{\text{th}}$ " and the lower about $1/4$ ".

JH says that butt joints should have "moderate edge contact." See page 89 of the first link above.
